***Lake Manitou
Aquatic Vegetation Management Plan
Update,
Fulton County, IN
March 14, 2008***

Prepared for:
Indiana Department of Natural Resources
402 W. Washington St. Rm. W273
Indianapolis, IN 46204

SePRO Corporation, Aquatic Control, Aquatic Weed Control, and ReMetrix

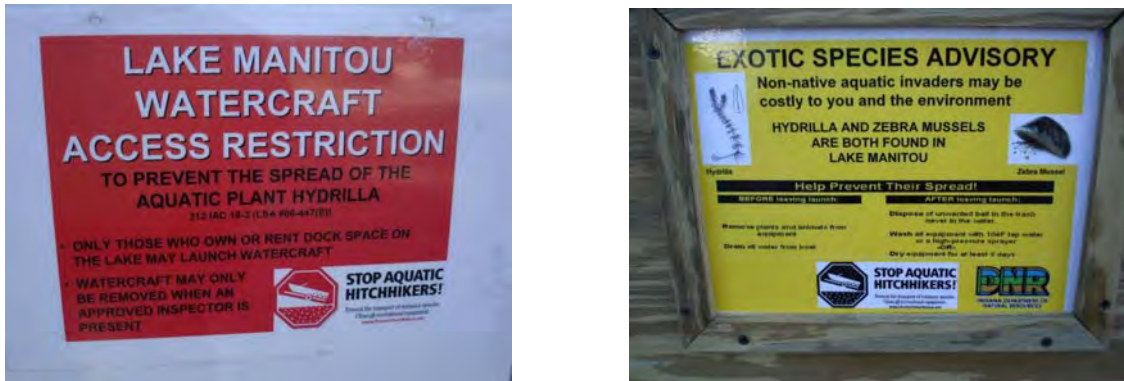
Figure 1. Advisory signs posted at the public launches on Lake Manitou.

Upon confirmation of species, access to the lake was immediately closed to the public to prevent the potential for spread through boats and boat trailers. The ramps were only open at predetermined times during 2006 and 2007 to allow those living around the lake an opportunity to get their boats on the lake or remove them for winter storage. During these times, boats were inspected for potential hydrilla fragments. No public access was permitted to the lake following hydrilla discovery in 2006 and all of the 2007 use season (Figure 1).

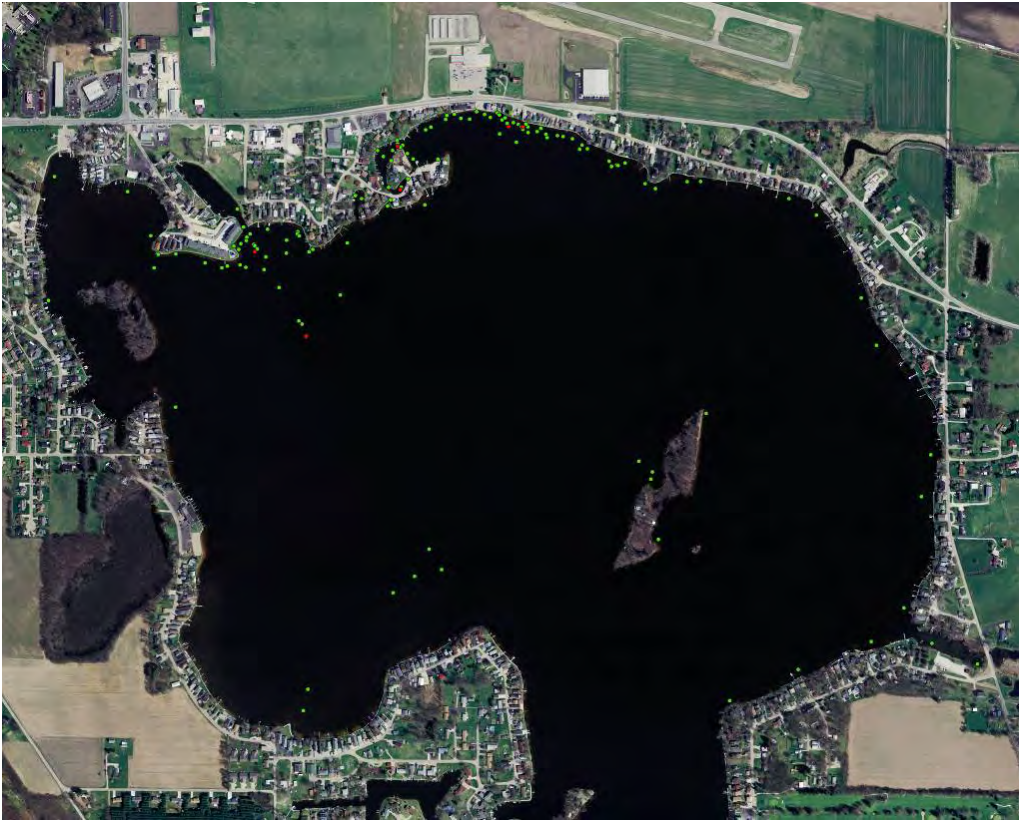
Figure 5. Tuber sampling locations from May 14-17, 2007. Green points represent areas where no hydrilla tubers were found. Red points indicate where hydrilla tubers were collected.

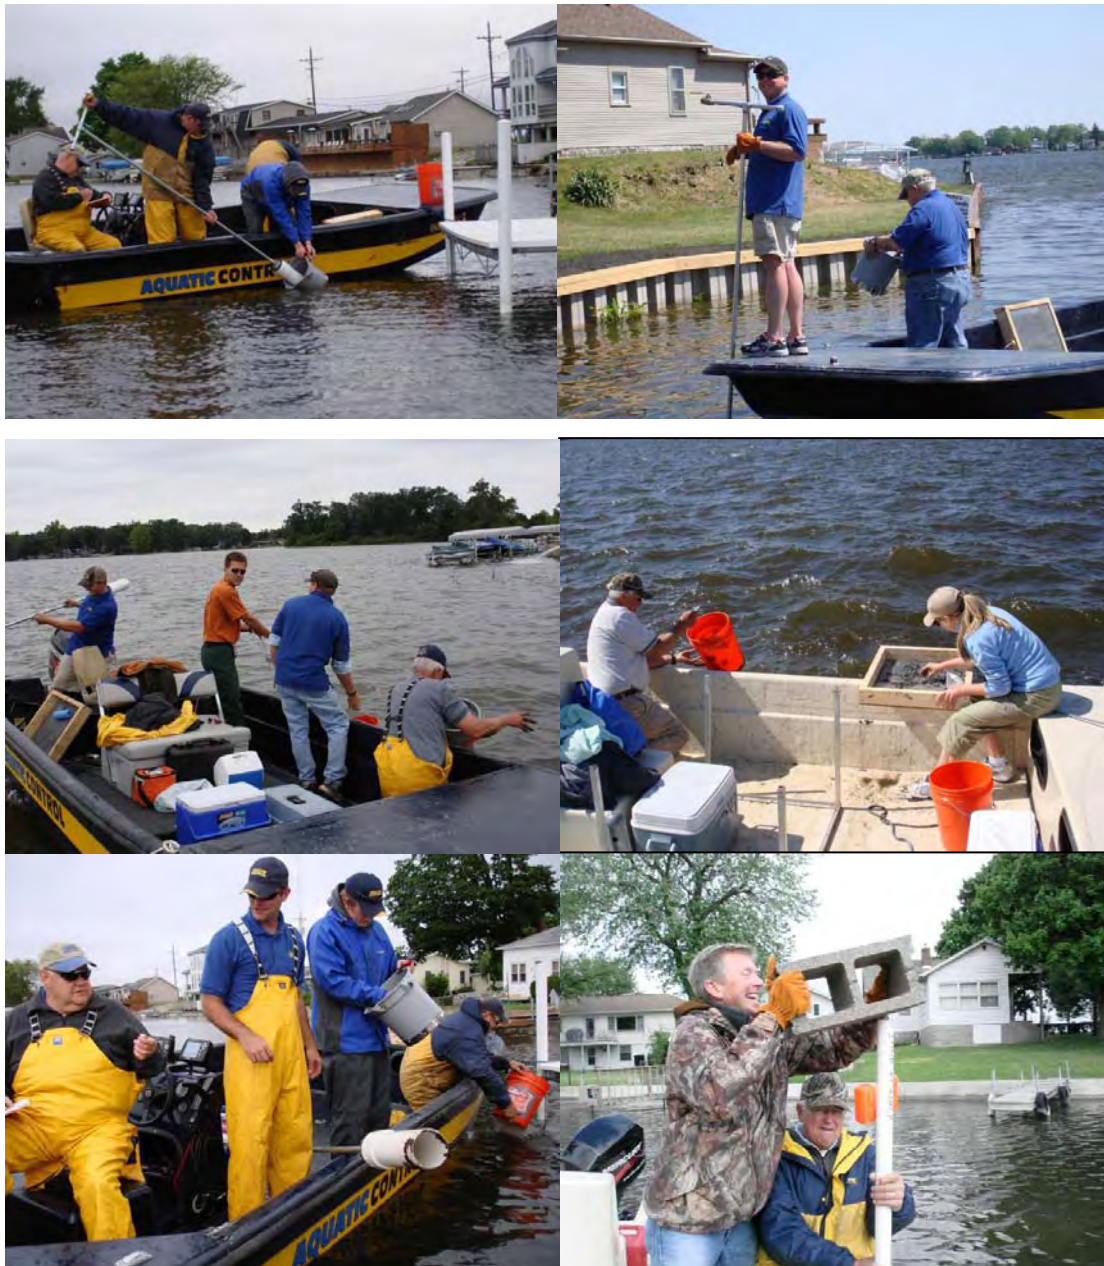
Figure 6. Tuber sampling equipment and personnel.

Tuber sampling equipment is shown in Figure 6. This sediment core sampling device was modified from the version described by Madsen et al. (2007), with galvanized pipe and schedule 40 pressure PVC (Figure 7). Galvanized pipe was $\frac{3}{4}$ inch in diameter, and connected air tight to the PVC coring head with a gasket, and a $\frac{3}{4}$ inch ball valve for venting. The coring head was a 4" PVC pipe with a length of ~18 inches.

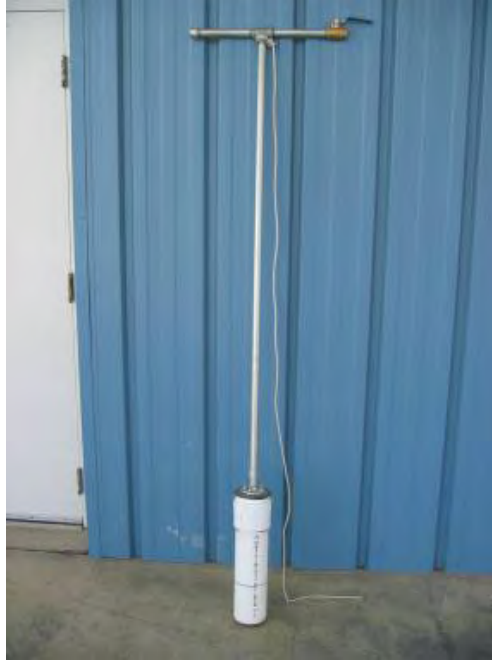
Figure 7. Coring device used for collecting sediments for tubers collections at Lake Manitou.

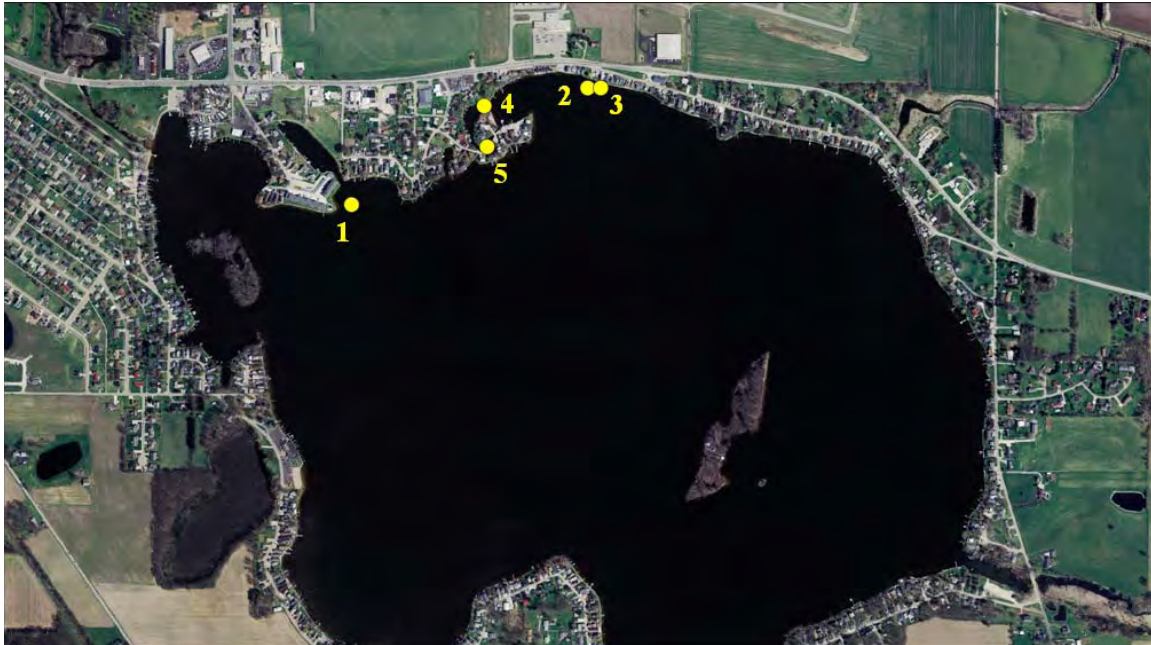
Figure 8. Locations of the five permanent hydrilla propagule monitoring stations, with station numbers.

Five permanent tuber sampling stations were identified based on hydrilla propagules collected and presence of vegetative tissue (Figure 8). At each station, 50 core samples were taken (total 250) at random from around the permanent station waypoints. The majority of hydrilla propagules were already sprouted, and only a single turion was found. Length of hydrilla and tuber to tip of sprout averaged approximately 4 to 5 inches. The results of the sampling are listed below in Table 5.

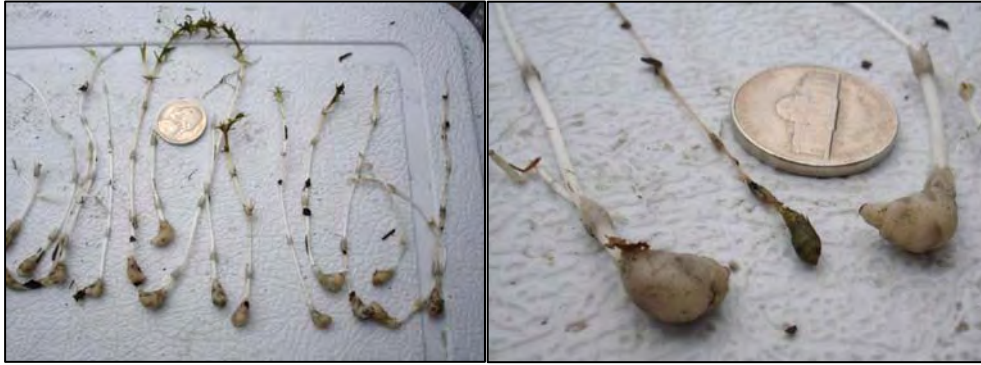
Figure 9. Hydrilla tubers and a turion found sprouting in Lake Manitou (May 2007).

Tubers were found with 2 to 6 inch sprouts on May 14th (Figure 9). Surface water temperatures at this time were approximately 19°C (66°F) and deep water temperatures at the sediment layer were approximately 9°C (48°F) (Table 7). Water temperature at 4 to 5 feet was approximately 15 to 19°C, the depth at which many tubers were collected. The timing of sprouting observed in Lake Manitou is consistent with reports from Steward and Van (1987), who reported that tubers sprout at 15°C (59°F)

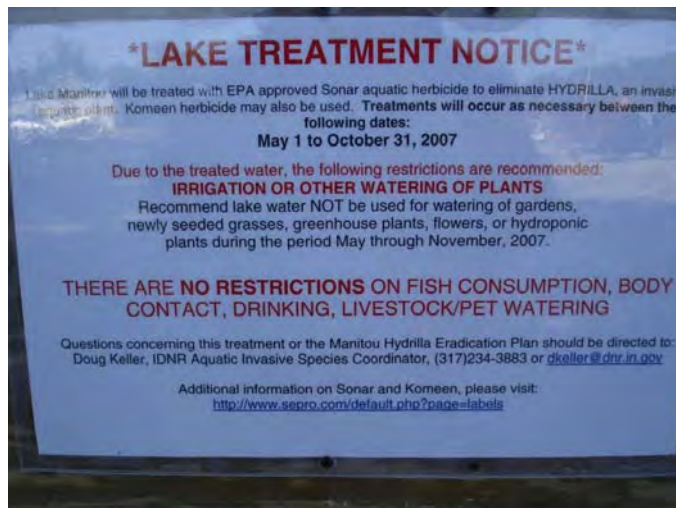
Figure 24. Lake posting for herbicide application for hydrilla control.

The initial Sonar application was completed on May 18, 2007 by Aquatic Control, Inc., with SePRO Corporation and ReMetrix personnel on site for technical assistance. The lake was posted with signage for public notification prior to Sonar application (Figure 24). Sonar AS was applied at a concentration of 6.4 ppb along with granular Sonar Q at a concentration of 4.0 ppb. Dosing was based on the thermocline depth of 17-feet (5.2

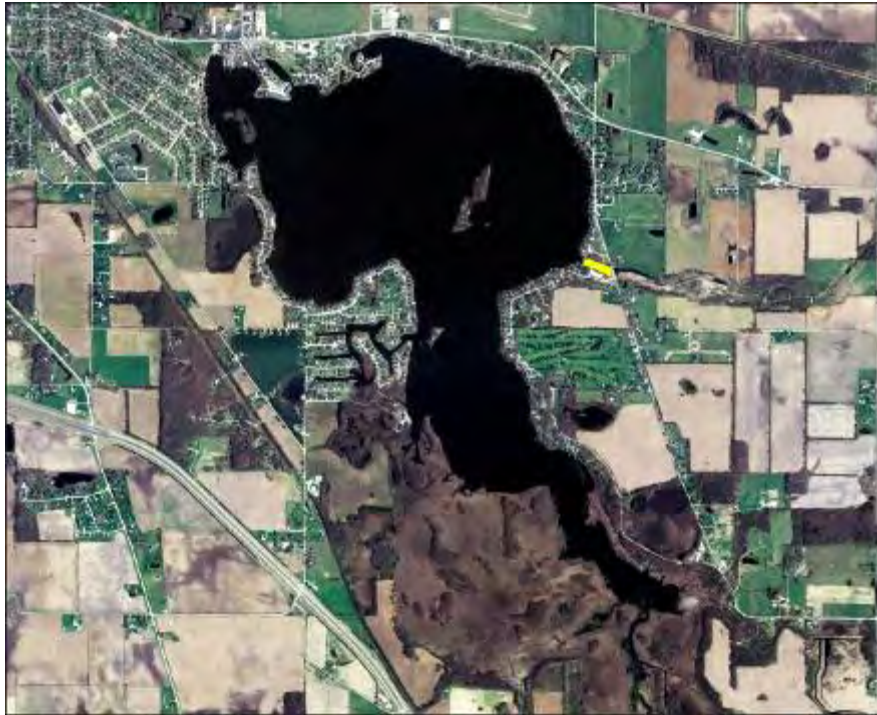
Figure 31. IDNR 2-acre lake-access contact treatment site (yellow polygon), June 6, 2007.

A 2-acre area at the IDNR access site was also treated with contact herbicides in an effort to reduce the threat of any vegetation being carried on watercraft and trailers as they are removed from the lake (Figure 31). This area was treated on June 6, 2007 by IDNR District Fisheries Biologist. This area was treated with 2.5 gallons of Komeen and 2.5 gallons Reward (a.i.: diquat). Plans were in place to treat any hydrilla biomass that occurred prior to or after the initial Sonar application using Komeen, however, no viable hydrilla plants were observed throughout the season and no contact herbicide treatment was completed.
